TECHNICAL REPORT REMR-CO-3

CASE HISTORIES OF CORPS BREAKWATER  
AND JETTY STRUCTURES

Report 9

SOUTHWESTERN DIVISION

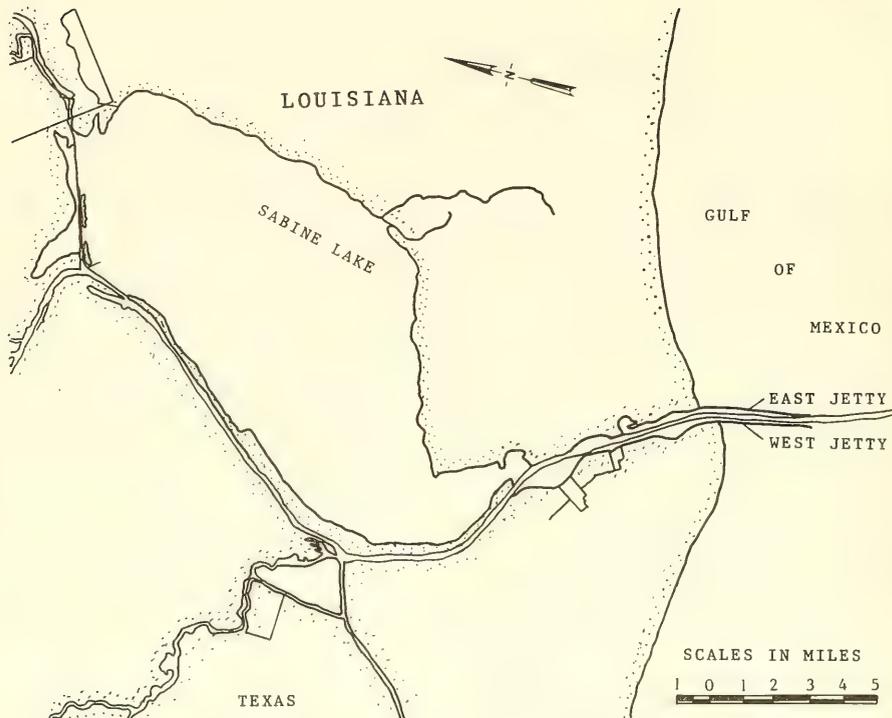
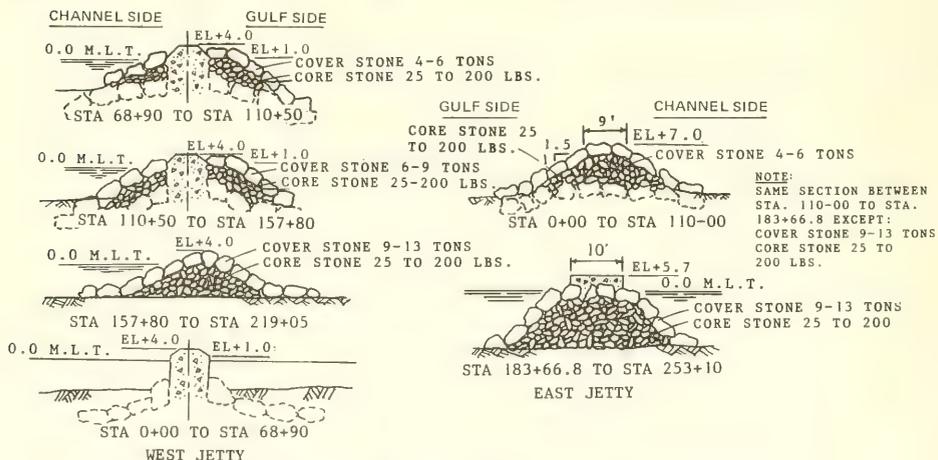
Figure 2. Location map and typical cross sections of Sabine Pass jetties

1986	No work has been done on the jetties since the 1960's, and they are considered to be in good condition, except for a 6,000-ft section at the west jetty's shoreward end.

1936- 1941	The jetties were capped with concrete. The east jetty cap, placed from sta 183+67 to sta 253+10, had an elevation of 5.7 ft mlt and a top width of 10 ft. The west jetty cap was placed on the existing cap to an elevation of +4 ft mlt and an overall width of 10 ft. Stone totaling 23,130 tons and 15,070 cu yd of concrete were placed at a total cost of \$608,000.
1957- 1958	The west jetty was repaired using 60,200 tons of stone at a cost of \$834,800 (location of repairs unknown). Cover stone weighed 9 to 13 tons each, and core stone weighed 25 to 200 lb each.
1960- 1966	Repairs were made from sta 60+00 to sta 183+67 and sta 68+00 to sta 179+50 on the east and west jetties, respectively (Figure 2). The east jetty was brought up to +7 ft mlt with a 9-ft crown width and 1V:1.5H side slopes. A similar cross section was used on the west jetty from sta 68+00 to sta 90+75 with the cover layer placed over the concrete cap. The remainder of the west jetty cap section was raised with core stone to +1 ft mlt, 1V:1.5H side slopes and covered with armor stone. The core stone varied from 25 to 200 lb. The cover stone varied from 4 to 13 tons between the landward and seaward ends of the repairs, respectively. A total of 430,000 tons (approximate) of stone was placed at a total cost of \$3,961,000.

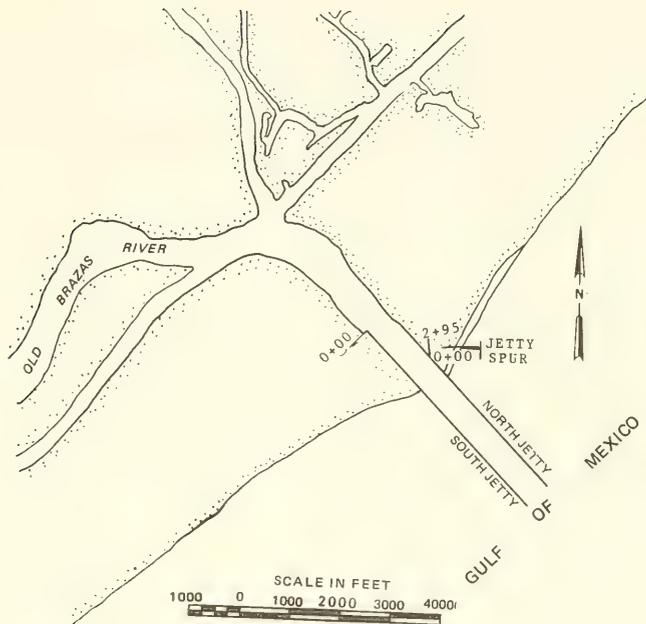
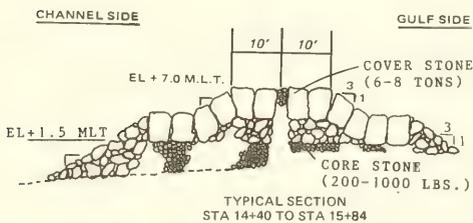
Figure 5. Plan view of Freeport Harbor jetties and typical south jetty repair sections

1986	Except for the more recent repair sections, the jetties are in poor condition, with many voids under the concrete caps and numerous cracks in the caps themselves. Jetty rehabilitation has been delayed pending authorized project improvements which include relocating the north jetty and channel deepening.

1968	Two sections of the south jetty, from sta 11+00 to sta 11+75 and sta 17+70 to sta 19+30, were repaired by buttressing the concrete cap with stone and placing concrete between sta 18+00 and sta 19+05 (Figure 5). The landward section was subjected to undermining and piping beneath the cap. The cap on the outer section had collapsed, due to undermining, with about 20 ft at +1 ft mlt and the remainder between +1 and +8 ft mlt. The concrete was placed to the original dimensions of +8 ft mlt and an 8-ft width. Stone was placed on the gulf side of the cap to +8 ft mlt, a 6-ft top width and 1V:2.5H side

Date(s)	Construction and Rehabilitation History
1968 (cont.)	slope. The remaining repairs consisted of buttressing the cap with 12-ft-wide bedding and cover stone layers. A 3-ft-wide layer of toe protection was placed along the outer edge of the repair sections. Stone sizes were 6 to 8 tons for the cover layer, 200 to 1,000 lb for the core (placed on seaside of outer section only) and toe protection, and 0.5 in. to 200 lb for the approximately 3-ft-thick bedding layer. Cost totaled \$65,300 using 4,410 tons of stone.
1977	Minor repairs were made at a total cost of \$9,200. (No details are available.)
1984	Two sections of the south jetty were repaired (Figure 5), and a 295-ft-long rubble-mound spur was placed at sta 8+40 on the north jetty's landward side. The south jetty repairs, from sta 14+40 to sta 15+85 and sta 19+20 to sta 20+20, consisted of a +7 ft mlt crown elevation, a composite width (including the cap width) of 20 ft and 1V:3H side slopes. A bedding layer of 0.5-in. to 200-lb stone was placed to +1.5 ft mlt and extended 26.5 ft from the jetty center line. Stone sizes were 6 to 8 tons for the cover layer and 200 to 1,000 lb for the core and toe protection. The toe protection was placed on a 1V:3H slope along the outer edge of the cover and bedding layers. The spur projected landward from the north jetty at a 30-deg angle and was built to an elevation of +6 ft mlt, a 5-ft top width, and 1V:1.5H side slopes. One-half inch to 200-lb blanket stone were used, except for a 90-ft section adjacent to the jetty. Single 4- to 6-ton stones were placed along the crown. The purpose of the spur was to minimize sand movement over the lower (+4 ft mlt) landward jetty section that was building a channel side shoal with the potential for future channel encroachment which would require subsequent maintenance dredging.

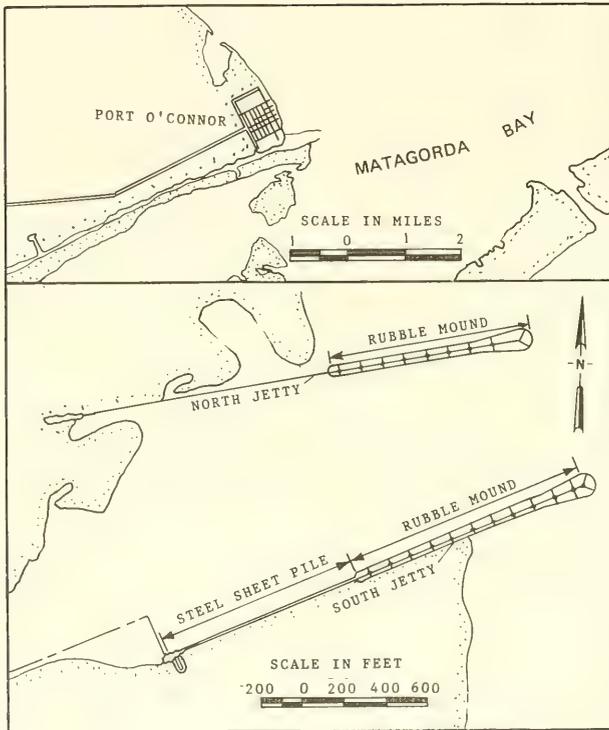
Figure 9. Location, plan view, and typical sections of Port O'Connor jetties

Date(s)	Construction and Rehabilitation History
1964- 1965 (cont.)	time of the repairs the jetties were in fair condition (mostly general corrosion), except at their outer ends where scour and active soil pressures were evident, and the shoreline was eroding at the landward ends. The cover stone size was determined from Hudson's slope stability formula and a maximum depth-limited wave height of 12 ft. Existing elevations along the jetties varied from +2 to -11 (seaward ends) ft mlt. The rehabilitation cost was \$397,800 and required 46,910 tons of stone.
1971	Riprap stone (0.5 in. to 200 lb) was placed on the north jetty landward end. The shoreline had eroded leaving a gap of approximately 50 ft. A total of 600 tons of stone was placed at a cost of about \$9,000.
1984	Except for general deterioration (corrosion) at several locations of the exposed sheetpiling, the jetties were considered to be in good condition (visual inspection). The present overall lengths of the north and south dikes are 2,300 and 2,250 ft, respectively.

1964- 1965	The jetties were rehabilitated by placing a rubble-mound cross section (Figure 9) along the outer 800- and 1,200-ft sections of the north and south jetties, respectively. In addition, scour protection was added to the remainder of the south jetty channel side, and shore protection was added at the landward ends of the dikes. The rubble-mound sections, with the existing jetties at the center line, were placed to an elevation of +4 ft mlt; side slopes were 1V:2H, and the crown width was approximately 10 ft (two cover stones wide, one on either side of the sheetpiling). The section was built up on a 2-ft-thick bedding layer (3 ft at seaward end) of 0.5-in. to 200-lb stone, a core of 200- to 1,000-lb stone, and a single layer of 2- to 4-ton cover stone. Filler stone (0.5 to 4 in.) also was placed with the core stone (a section 3 ft wide on either side of the sheetpiling and extending downward at 1V:1H side slopes). The bedding layer extended from 5 ft (landward) to 15 ft (seaward) beyond the toe of the cover stone layer. The landward 700 ft of south jetty bay side rubble mound consisted of a 2-ft-thick bedding layer placed between 0 and +2 ft mlt followed by a 2-stone-wide cover layer (+4.5 ft mlt crest elevation). South jetty scour protection was placed on 950 ft of the channel side (landward of the rubble-mound section) and consisted of a 2-ft-thick by 10-ft-wide layer of 0.5-in. to 200-lb stone. The north jetty was extended 50 ft landward, and a 30-ft-long perpendicular spur was added at the landward end (bay side) of the south jetty. This shore protection used 0.5-in. to 200-lb stone placed between 0 and +4 ft mlt with a 4-ft crown width and 1V:2H side slopes. At the

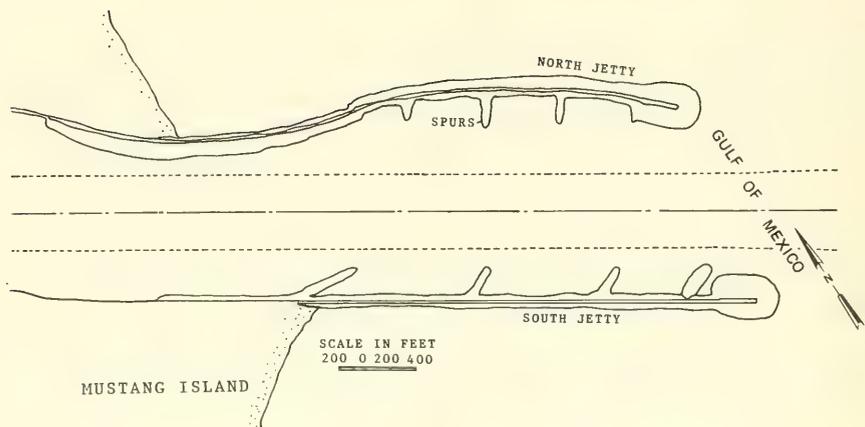
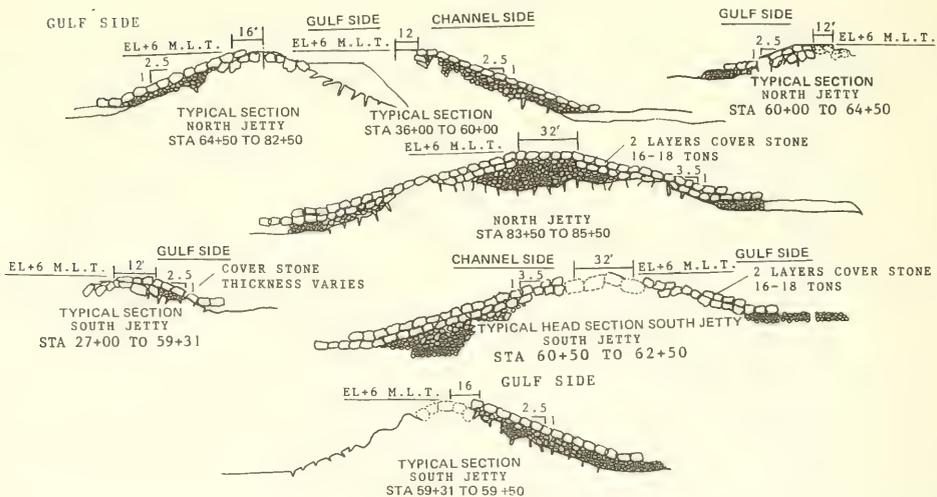
Figure 11. Aransas Pass jetties, plan view and typical cross sections

1967	<p>Hurricane Beulah's passage in October displaced cover stone at several locations, with an estimated 100 pieces missing or displaced from each jetty. Near the landward ends of the jetties sand was washing or piping under the concrete caps and into the ship channel. It is not known whether this piping was due to the storm or if it had been a previous problem. These sections were located from sta 12+00 to sta 24+00 on the north jetty and from sta 10+00 to sta 25+00 on the south jetty (landward ends at sta 0+00).</p>

Date(s)	Construction and Rehabilitation History
1908- 1917	The north or Haupt jetty was repaired and extended 3,490 ft landward which closed the gap, and a 7,385-ft-long south jetty was constructed (Figure 11). The jetties were roughly parallel, spaced 1,500 ft apart, with the south jetty extending 1,150 ft seaward of the north jetty. The jetties were built up to +5 ft mlt and crest widths of 10 to 20 ft using small riprap (15 to 200 lb), large riprap weighing 200 lb to 7 ton, and crest stone greater than 7 tons comprised 7 percent of total. The total quantity of stone placed on the north and south jetties was 162,400 and 253,900 tons, respectively. These totals include minor repairs made during 1916-1917. The total cost for jetty improvements during this period was \$1,544,500. In 1911, portions of the Mansfield and Nelson jetties were removed from the channel at a cost of \$14,300. The authorized 20-ft channel depths were obtained during construction as the tidal flow and resulting bottom scour were gradually confined.

Date(s)	Construction and Rehabilitation History
1964- 1966	<p>The jetties underwent major rehabilitation using the recommendations and design proposed in 1962 (Figure 11). The new seaward ends of the 4,950- and 3,550-ft-long repair sections terminated 790 and 1,135 ft from the original seaward ends of the north and south jetties, respectively. The south jetty repairs consisted of a rebuilt gulf side slope, a 200-ft-long head section, and a 250-ft channel side spur located 550 ft landward of the head. The north jetty repair section had the landward 2,410-ft channel side and adjacent (seaward) 2,250-ft gulf side slopes rebuilt. The final 300 ft were rebuilt as a transition and 200-ft head section. The head sections had a crown elevation of +6 ft mlt, a 32-ft crown width and 1V:3.5H side slopes. The 16- to 18-ton cover stone was placed as a double layer on the side slopes and single layer on the crown. The 200- to 4,000-lb core stone was partially supplemented with 0.5- to 4-in. filler stone (in a section extending beneath the crown at 1V:1H side slopes) for the purpose of decreasing structure permeability. The 0.5-in. to 200-lb blanket stone was placed in a 5-ft-thick layer and extended 50 ft beyond the toe of the cover layer. The jetty trunk sections were rebuilt to +6 ft mlt and a 1V:2.5H side slope. The crown extended two cover stones in width from the existing 12-ft-wide concrete cap sections or 14 ft from the center line of the north jetty grouted cap (1,800-ft section). The single layer of cover stone varied from a minimum of 2 to 4 tons at the south jetty landward end to a maximum of 16 to 18 tons at the jetty seaward ends. The blanket layer was placed in 3-, 4-, or 5-ft thicknesses and extended 10 ft beyond the toe of the cover layer. Prior to placing the core stone the existing void spaces were chinked with filler stone. The filler, blanket, and core stone size ranges were the same throughout the repair sections (see above). The south jetty groin consisted of core stone placed to -18 ft mlt, a 10-ft crown width, and 1V:1.5H side slopes. The core stone was placed on a 5-ft layer of blanket stone which extended 10 ft beyond the toe of the core stone. The total cost of rehabilitation was \$3,367,000 and required 410,250 tons of stone. The jetty design was based on Hudson's slope stability formula, depth- and fetch-limited wave heights, and a maximum storm surge level of +13 ft mlt. The 18-ton maximum cover stone was inadequate for maximum design conditions but was selected for practical and economic reasons.</p>

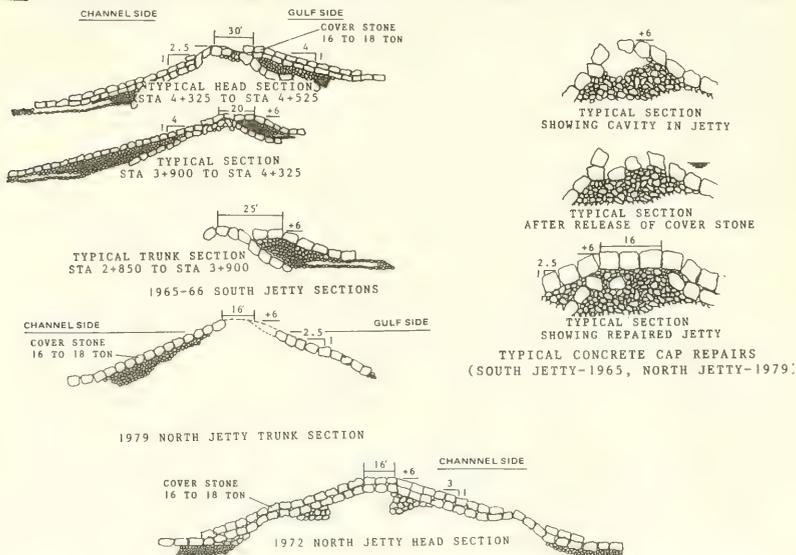
Figure 15. Typical repair sections of the Brazos Island jetties

1977- 1979	<p>By the end of 1977, sections of the north jetty concrete cap had collapsed, other sections were cracking, and its seaward end needed repair. All of the noted areas of cap damage were located along the channel side. The damaged areas were similar to those seen previously on the south jetty cap where undermining and settlement of the underlying stone had created cavities beneath the cap. It was thought that Hurricane Anita in August 1977 was the force which triggered most of the cover stone breakage and collapse, because the jetty was considered to be in good condition during a June 1977 inspection. The north jetty channel shoreline was continuing to erode. Since 1962, the shoreline had receded about 200 ft, a rate of 13 ft per year. The channel end of the 1971 shoreline protection was now offshore. (The 1961 shore protection stone was virtually non-existent.) During 1978-1979, repairs were made to the north jetty and adjacent shore protection. The seaward 35 ft and 1,700 ft of the jetty trunk were brought up to grade using 16- to 18-ton cover stone, 100- to 4,000-lb core stone (2,000-lb maximum on landward 1,000 ft of trunk), and 0.5-in. to 200-lb blanket stone. The trunk section (Figure 15), starting 500 ft from the seaward end and extending landward, had a 16-ft crown width, a +6 ft mlt crown elevation, and 1V:2.5H side slopes. The concrete cap was broken up, and the released cover stone projecting above +1 ft mlt was removed and used as cover stone in the shore protection (Figure 15). New core and a single layer of cover stone then were placed to obtain the required design geometry. A 3-ft-thick bedding layer was placed from</p>

1980	<p>In August, storm waves from Hurricane Allen caused significant damage to the jetty heads and a section of the north jetty trunk had been breached. The breached section was about 50 ft long and located 350 ft from the head.</p>
1984	<p>There are several places along the jetties where the foundation has settled, resulting in the cover stone lying below mlt.</p>

Date(s)	Construction and Rehabilitation History
	<p>breaking up the concrete cap at sections where underlying cavities had formed. The released cover stone was left in place and overlaid with new cover stone bringing the sections up to the +6 ft mltw design elevation. The north jetty repair, located approximately 3,500 ft from the seaward end, brought the channel side up to grade by placing blanket stone, resetting existing cover stone, and adding new 200- to 1,000-lb core stone and 2- to 4-ton cover stone. The 3-ft-thick blanket of 0.5-in. to 200-lb stone extended 10 ft beyond the toe of the cover layer. The section was brought up to +6 ft mlt and a side slope of 1V:2.5H. Water depths were -35 ft mlt along the seaward end of the north jetty toe and from -20 to -40 ft mlt along the seaward end of the south jetty toe. The authorized 38- by 300-ft channel has been maintained since 1957. Hudson's slope stability formula was used in the design with 10- to 35-ft wave heights. The design storm surge was +13 ft mlt. The stone sizes used were smaller than required to satisfy a no-damage criterion, with slope stability coefficients varying from 2.5 to 12.5 but being used for practical and economic reasons. The total cost of the repairs was \$584,000 using a total of 60,600 tons of stone.</p>

Date(s)	Construction and Rehabilitation History
1977-1979 (cont.)	<p>the base of the existing jetty and extended 10 ft beyond the end of the new cover layer. The seaward end repair was identical to the 1971-1972 work, except that 1V:3H side slopes were used throughout. Displaced cover stone was reset on the adjacent 100 ft of jetty. The north jetty shore protection was extended 1,470 ft along the channel shoreline; this included 150 ft of the existing shore protection which was salvaged and rebuilt, and repairs were made to the existing section. The design was nearly identical to that used in 1968 on the existing shore protection. (Toe protection was 200 to 1,000 lb and placed with a top width of 5 ft.) The jetty design was based on Hudson's equation with a maximum wave height of 26.5 ft (trunk) and a maximum surge level of +10 ft mlt. Similar to previous improvements, the selected jetty design was chosen for economic and practical considerations in lieu of a "no damage" design. Total cost of the jetty repairs and shore protection was \$5,905,000 using approximately 140,000 tons of stone.</p>
